Navajo Abandoned Uranium Mine

Site Screen Report

NA-0424 AUM Site

August 2010

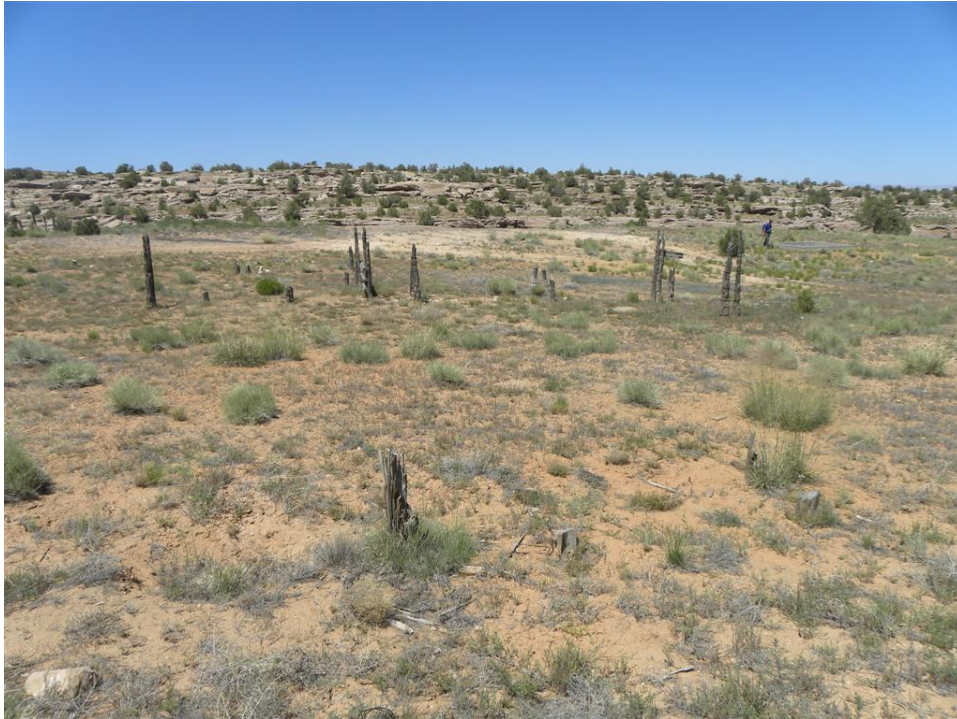
Photo 1. NA-0424 site

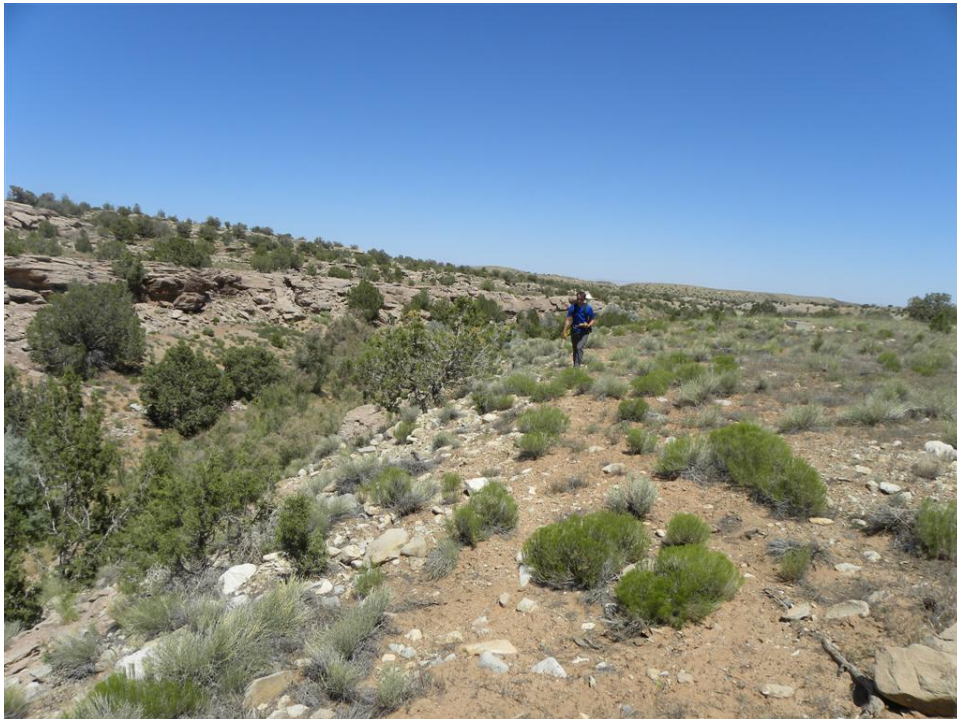
Photo 2. NA-0424 site, drainage north of site (looking east)

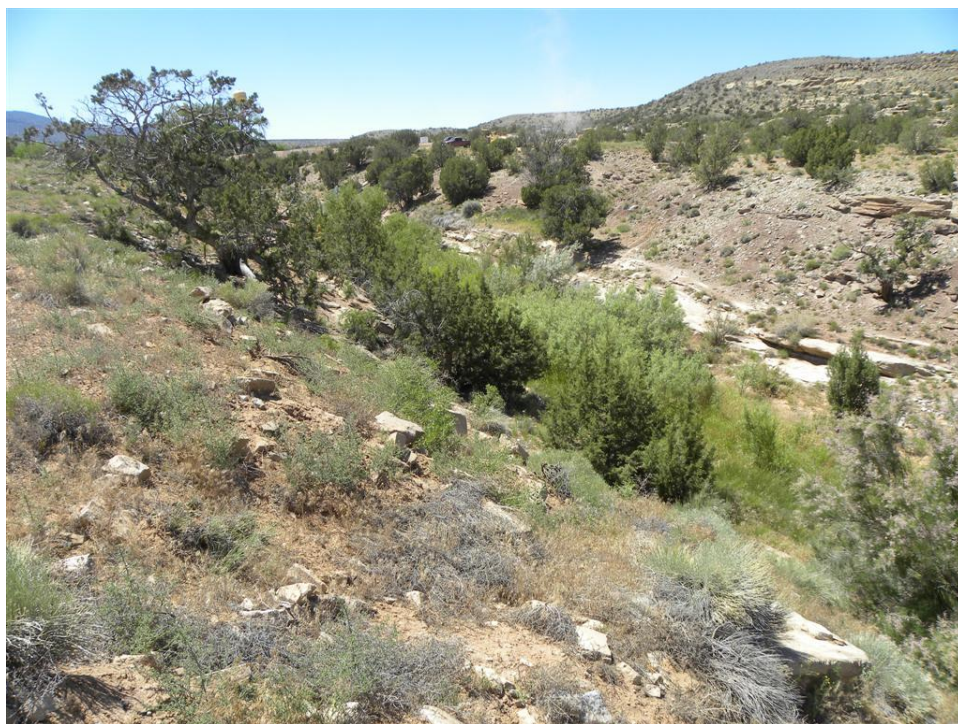
Photo 3. NA-0424 site, drainage north of site (looking west), towards Beclabito Day School
